PROBATIONARY FIREFIGHTER TRAINING FIRE STATION 11-C

Un-reinforced Masonry

INTRODUCTION

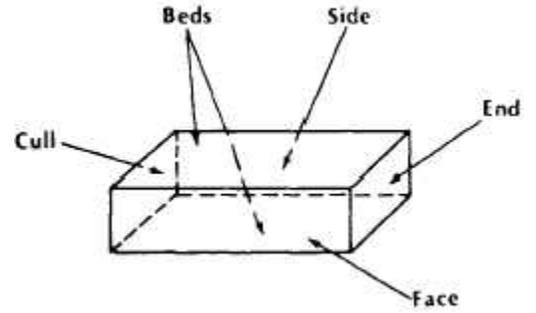
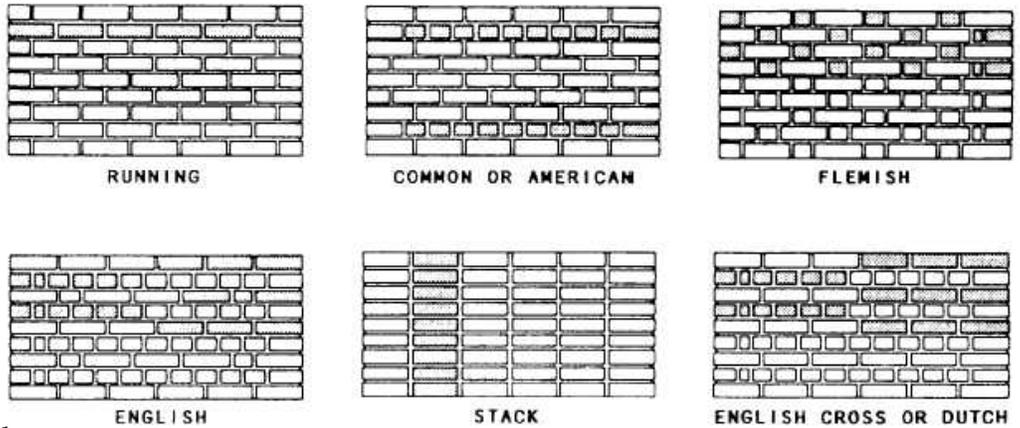
- U.S. Standard size brick: 2 1/4" x 3 3/4" x 8"
- Bricks weigh 100 – 150 lbs per cubic foot
- 6 sides of a brick
- Strength of a brick structure comes from:
 - brick strength
 - mortar strength and elasticity
 - bricklayer workmanship
 - brick uniformity
 - method used to lay brick

- Strength of a single brick:
 - Ingredients and manufacturing method
 - Ultimate compressive strength as low as **1,600 psi**.
 - Well-burned brick has compressive strength exceeding **15,000 psi**.
 - Load carrying capacity of a brick structure is cut in half when sand lime mortar is used versus Portland cement mortar
 - The compressive working strength of a brick wall or column laid with sand lime mortar normally ranges from **500 to 600 psi**

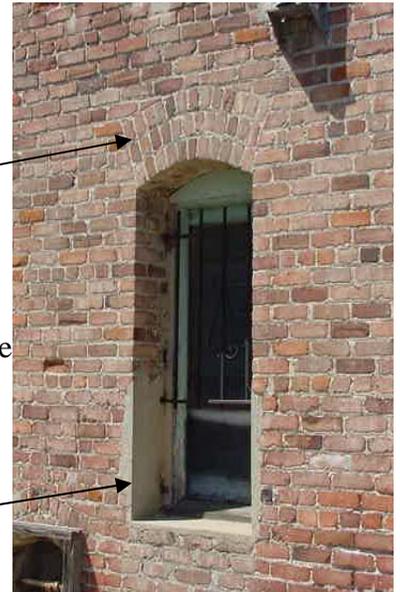
- Brick walls up to 3 wythes thick
 - 1 wythe = 1 masonry unit
 - In excess of **13” and tapering vertically**
- Weak Foundation Walls
 - Masonry
 - Rock
 - Motor used contains very little cement
 - Deteriorates from moisture penetration over time
 - Concrete was used in some structures
- Lintels used over windows and doorways
- Wood floor and roof assemblies
- Fire cut joists (allowed floors and ceilings to collapse without pulling the walls in)
- No rebar

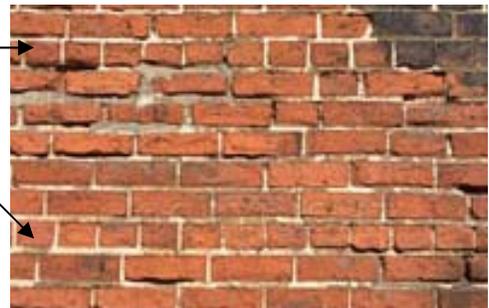
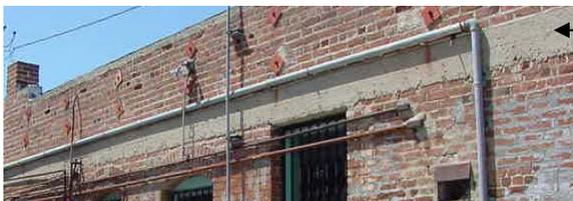
- King Rows
 - Header course every 4-7 stretcher courses
 - Header course showing the ends of the bricks
 - Ties wythes together
 - Today’s construction will use metal ties and corrugated steel to serve this purpose

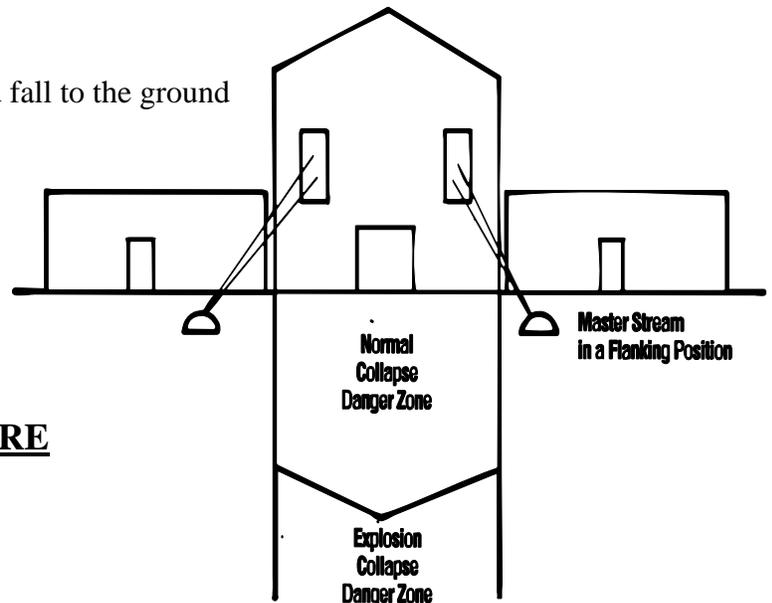
- As the collapsing joist inside fall, the exterior walls are pulled in causing a break horizontally along the wall in between the ground and the failing member.
- The upper portion of the wall collapses inward
- The lower portion of the wall collapses outward

Curtain Fall

- The bricks and blocks peel away and fall to the ground

- A collapse zone should be established 1 ½ times the height of the structure

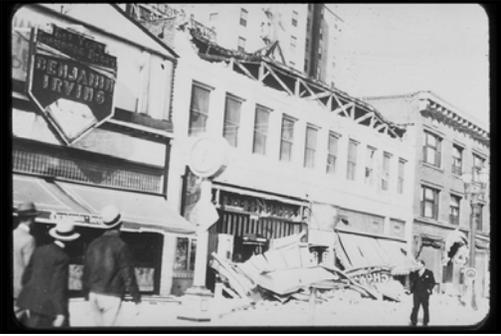
Parapet and marquee damage
